PERTLE SPRINGS LAKE DAM

JOHNSON COUNTY, MISSOURI

MO 20044

PHASE 1 INSPECTION REPORT NATIONAL DAM SAFETY PROGRAM

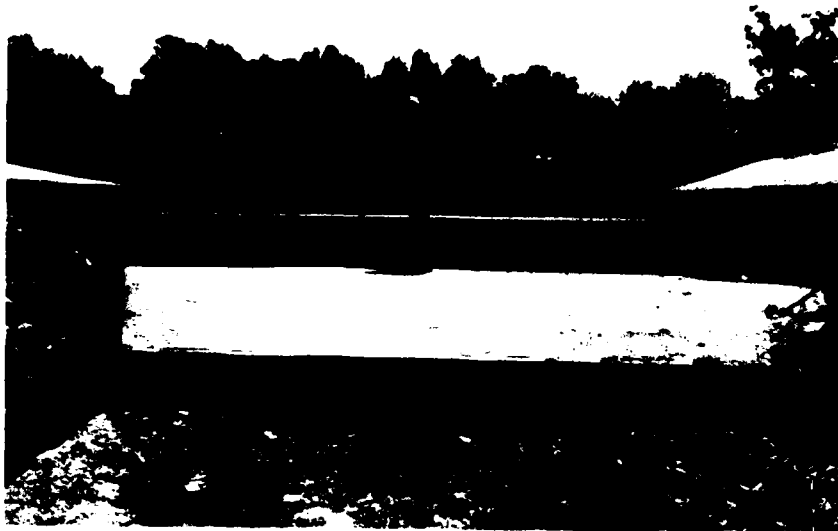
The emergency spillway consists of a rectangular concrete notch inlet structure with a concrete control sill which discharges onto a backfill concrete apron then into a downstream soil and rock channel. This concrete was inspected and found to be in satisfactory condition. As previously noted there was clear seepage (5 gpm) coming from under the emergency spillway backfill concrete apron. Also some unmeasurable seepage was observed coming from under the concrete sill. It was noted that the control sill concrete had been repaired.

PHOTO 9: EMERGENCY SPILLWAY CONCRETE SILL LOOKING UPSTREAM

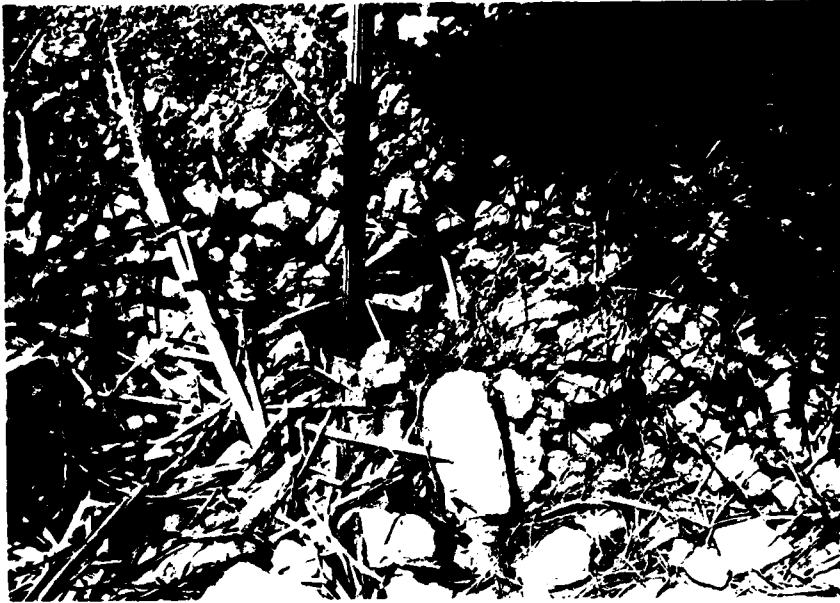
Many animal burrows were observed on the embankment. The area considered as the upstream channel to the lake contains several small dams and lakes located in an area of low hills. The lake water was noted to be clear containing a minor amount of siltation.

Burrowing animals will continue to damage the embankment if no program is undertaken to eliminate them. Piping failure of the embankment has resulted in similar small earth dams due to burrowing animal damage.

PHOTO 13: ANIMAL BURROW IN UPSTREAM FACE OF DAM

(3) The animal burrows in the embankment should be repaired since they can lead to piping. Control measures should be implemented to discourage animal activity in the area.
